# Manhole Inspection Summary

Manhole # S290\_\_017MH

**Location** Address: **1143 WICOMICO**

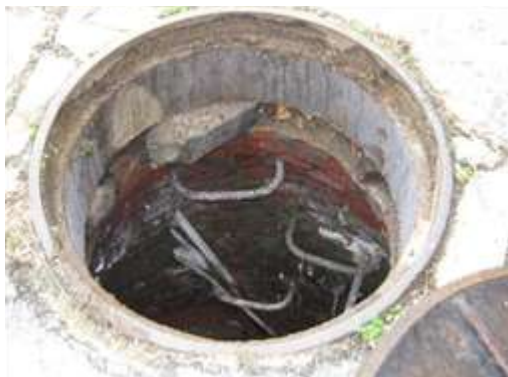
Defect 2

**Frame** Offset: **0** (in.) Condition: ☐ Sound ☐ Cracked ☒ **Leaks**

Condition: ☐ Sound ☐ Cracked ☐ Root Intrusion ☒ **Loose Brick** ☒ **Deteriorated**

frame leaks; chimney deteriorated with loose brick

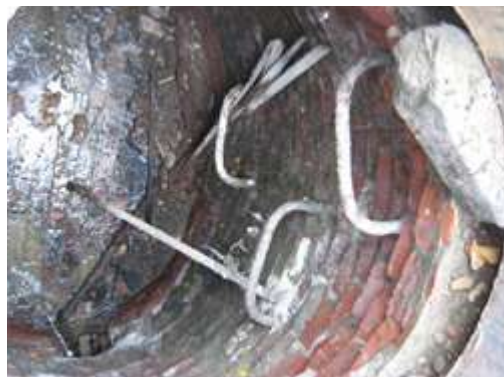
Defect 1

Condition: ☐ Sound ☐ Cracked ☐ Root Intrusion ☐ Deteriorated ☐ Leaks ☒ **Debris**

DEBRIS ON BASE

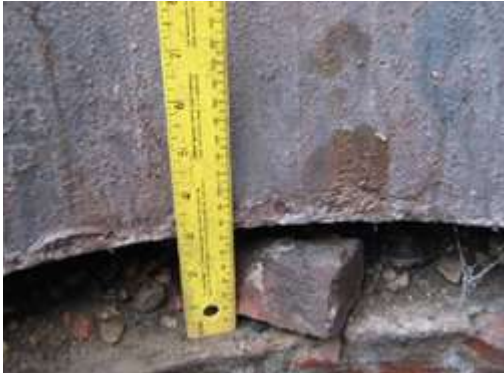
### Defect 3

Infiltration: ☐ None ☒ **Joint** ☐ Cracks ☐ Mortar ☐ Roots ☐ Wall

infiltration from gap at chimney joint

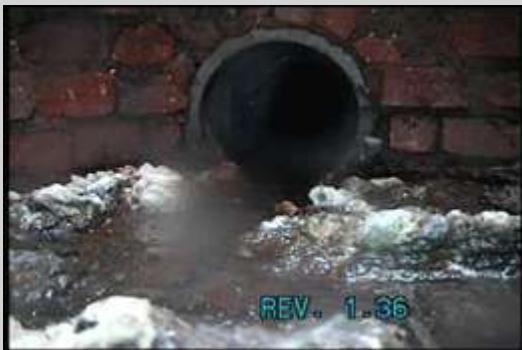
12 O'Clock Outflow

8 in. Circular Gravity Sewer  
Pipe Out @ 12 O'Clock

Pipe Height: **8.4** (in.) Rod and Bar (Angled)  
Pipe Material: **Clay** ☐ Pipe Lined  
Invert Depth: **5.47** (ft.) Flow Characteristics: **None**  
Deposits: ☒ None ☐ Mud ☐ Sludge ☐ Debris ☐ Grease  
Silt Depth: **0** (in.) Deposits Extent:  
Infiltration: **None** Pipe Seal Cond: **Sound**

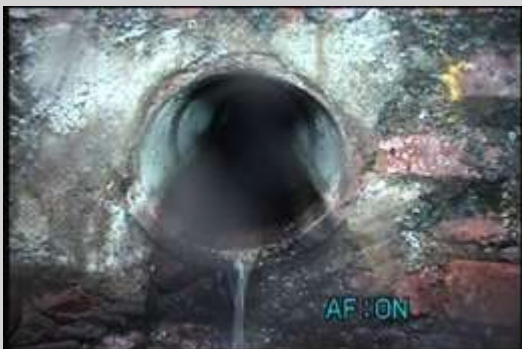
6 O'Clock Inflow

6 in. Circular Gravity Sewer  
Pipe In @ 6 O'Clock

Pipe Height: **6** (in.) Rod and Bar (Angled)  
Pipe Material: **Clay** ☐ Pipe Lined  
Invert Depth: **4.51** (ft.) Flow Characteristics: **Fast**  
Deposits: ☒ None ☐ Mud ☐ Sludge ☐ Debris ☐ Grease  
Silt Depth: **0** (in.) Deposits Extent:  
Infiltration: **None** Pipe Seal Cond: **Sound**
